Manhole Inspection Summary

Manhole # S47I2_008MH

Insp Date: **1/14/08 8:23 AM**

Location Address: **4810 Cherry-Church**

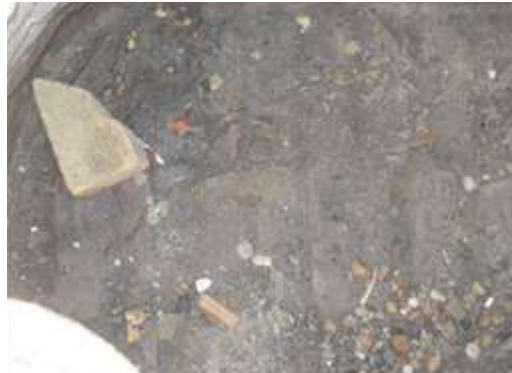
Defect 1

Slight debris on bench

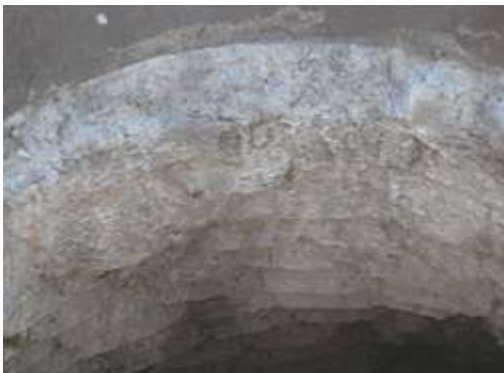
Defect 2

Chimney infiltration

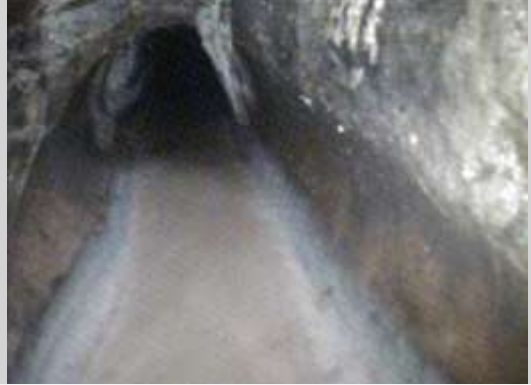
12 O'Clock Outflow

Pipe Height: **9.6** (in.) Rod and Bar (Angled)
Pipe Material: **Clay** ☐ Pipe Lined
Invert Depth: **5.12** (ft.) Flow Characteristics: **Fast**
Deposits: ☒ None ☐ Mud ☐ Sludge ☐ Debris ☐ Grease
Silt Depth: (in.) Deposits Extent:
Infiltration: **None** Pipe Seal Cond: **Broken**

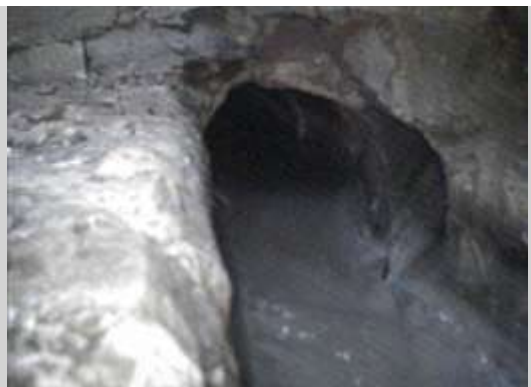
6 O'Clock Inflow

Pipe Height: **9.6** (in.) Rod and Bar (Angled)
Pipe Material: **Clay** ☐ Pipe Lined
Invert Depth: **5.04** (ft.) Flow Characteristics: **Fast**
Deposits: ☒ None ☐ Mud ☐ Sludge ☐ Debris ☐ Grease
Silt Depth: (in.) Deposits Extent:
Infiltration: **None** Pipe Seal Cond: **Sound**

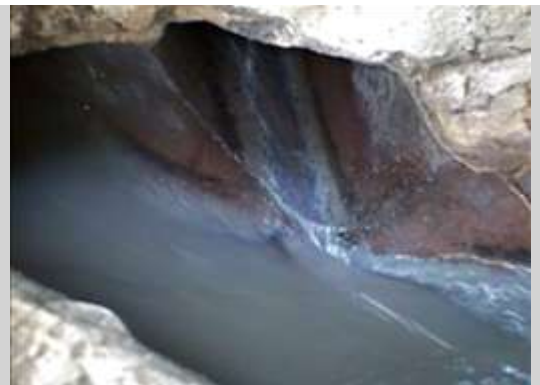
9 O'Clock Inflow

Pipe Height: **8.4** (in.) Rod and Bar (Angled)

Infiltration: **None** Pipe Seal Cond: **Sound**
